# Success Story: Retrofitting in a Fertilizer Production Plant

## The Challenge

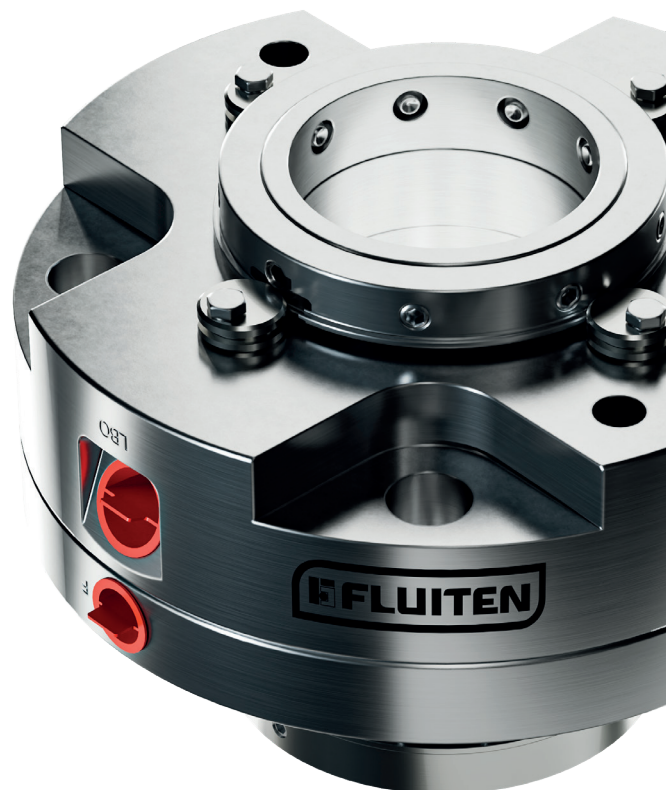
The minimal margins between the vapor pressure of the pumped fluid and the pressure in the stuffing box led to evaporation of the liquid film between the sealing surfaces, causing:

- Overheating of the seal and secondary gaskets
- Formation of blistering and premature wear on the surfaces

To avoid modifications to the existing flushing system, an **improved solution** was devised while maintaining the current flush plan (11-52, with an atmospheric pressure tank).

- Fluiten **BM6T** cartridge mechanical seal, compliant with API682 4th Edition.
- Shrink sleeve on the process side to increase internal pressure.
- Orifice modification on **plan 11** to enhance flushing flow.
- High-efficiency circulation device for **plan 52**, providing better cooling.
- Narrow face design to reduce heat generated by the seal during operation.

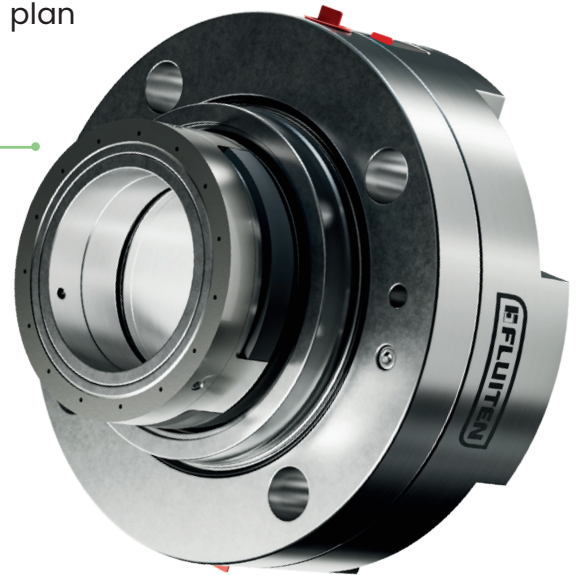
The configuration was designed to be fully **interchangeable** with the existing system without requiring modifications to the pump stuffing box
